AFT Fire Wall Testing Procedure

TESTING REGULATION DETAILS

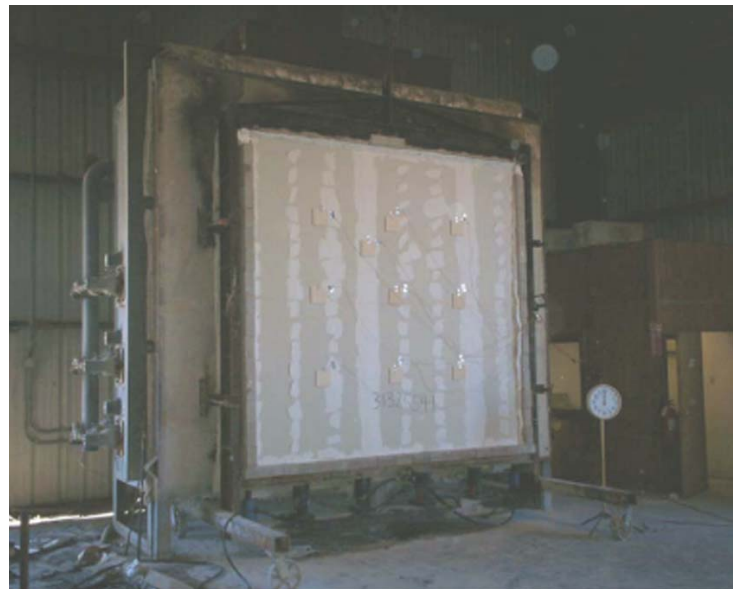
The furnace has observation windows on the sides and front. Within minutes of starting the test the interior of the gas-fired furnace turned "cherry red". The first noticeable observation is the drywall paper burning and subsequently the joints opening and the studs burning. As the test continues, the next observation is stress cracks forming in the drywall. Eventually the drywall falls as the studs behind have burned and no longer support the drywall. All that remains is the cellulose insulation adhering to the back walls as well as the studs in the back portion of this specific assembly.

A 10 foot x 10 foot wall assembly of the specific configuration was built and placed at the face of a gas-fired furnace. Thermocouples are placed in furnace area and on the unexposed side (opposite the furnace) drywall. The thermocouples are connected to a computer that records their temperature at specified time intervals.

The gas-fired furnace is controlled to parallel the time-temperature curve specified in ASTM E119. The hot side reaches a temperature of 1850 degree F during the two hour test. It is fitted with six propane/air burners positioned on the left and right side walls, designed to allow an even heat flux distribution across the face of the test specimen while allowing no direct flame impingement. Conditions of fire endurance acceptance are no passage of flame or gases hot enough to ignite cotton waste as well as temperature rise limitations on the unexposed surface. The average temperature of the thermocouples on the unexposed side cannot rise more than 250 degrees F from their initial temperature or no single thermocouple can rise more than 325 degrees F.
